**SAWMILL RUN DAM
(ARMCO)**

NDI I.D. NO: 915

**PHASE I INSPECTION REPORT
NATIONAL DAM INSPECTION PROGRAM**

D'APPOLONIA CONSULTING ENGINEERS
10 DUFF ROAD
PITTSBURGH, PA. 15235
SEPTEMBER 1978

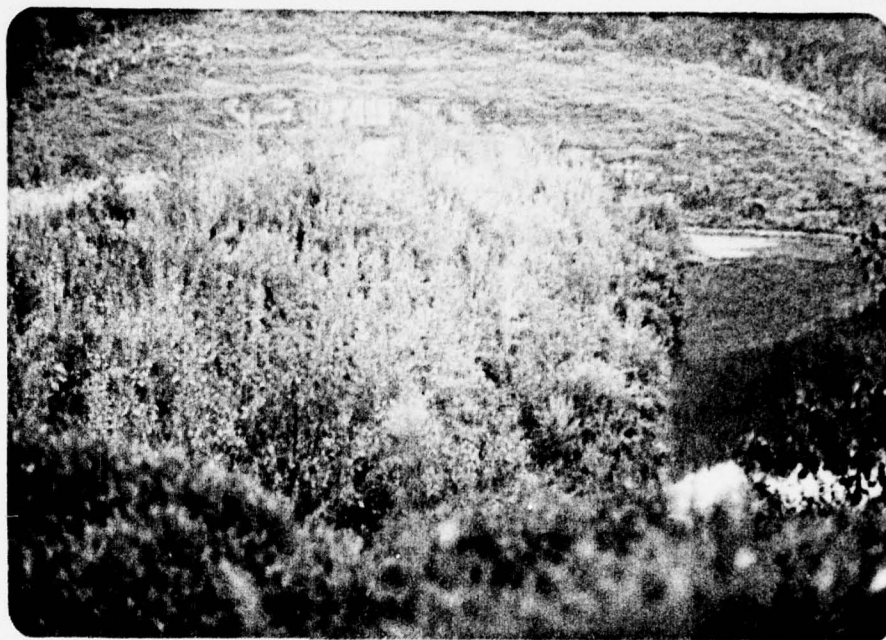
Upstream Face

Both upstream and downstream faces of the dam were observed to be covered with brush and trees up to 10 feet high. This condition precluded close inspection of the embankment. To the extent that is visible, no signs of distress or seepage were found on the embankment or immediate area below the toe. A swampy area was observed on the left abutment approximately 200 feet downstream from the dam located between the valley wall and the ash disposal area haul road. Standing water is visible, but no flow was observed. It appeared that the probable source was surface runoff trapped due to surface grading for the slag disposal area.

1. Brush and trees should be removed from the upstream and downstream faces of the dam.
2. The steep rock cut along the spillway channel should be observed frequently and necessary remedial measures taken to prevent major rock slides that may partially block the spillway channel.
3. It is also recommended that an upstream control be installed on the outlet pipe, consisting of either a permanent structure or temporary means of blocking the upstream end of the pipe in the event it is necessary to drain the outlet pipe.
4. The owner should provide around-the-clock surveillance during periods of unusually heavy runoff and develop a formal warning system to alert the downstream residents in the event of emergencies.
5. It is recommended that the owner be advised that the dam and the appurtenant structures should be inspected regularly and be properly maintained.

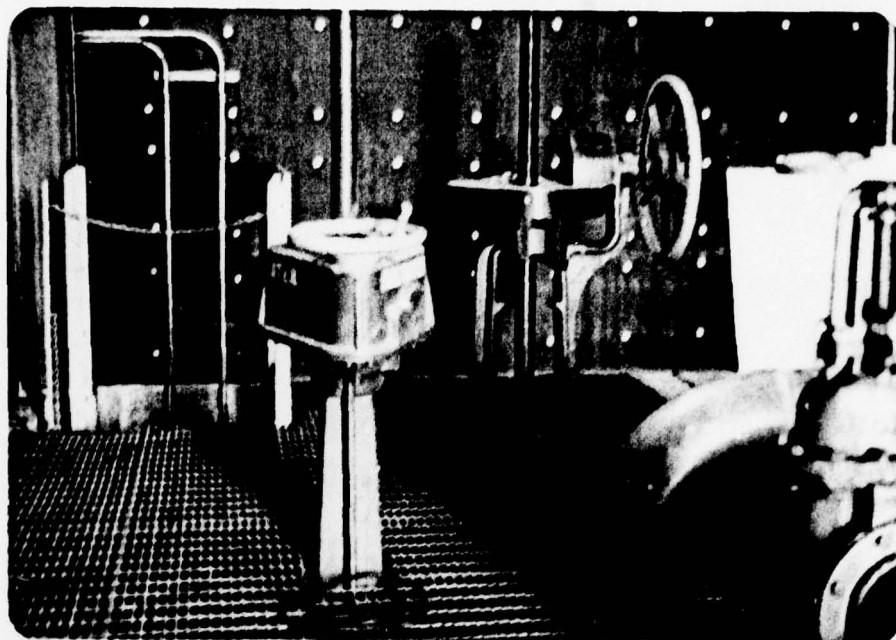
Photograph No. 7
Blow-off valve control.

The blow-off valve was operated and observed to be functional.
